D&S Car Wash Equipment Company  
Official Document

Document Title: IQ 2.0 SHAFT FASTENER UPGRADE INSTRUCTIONS FOR 10SHFT1080-KIT-INVOICE

ID: 10DOC1201      Revision: 1

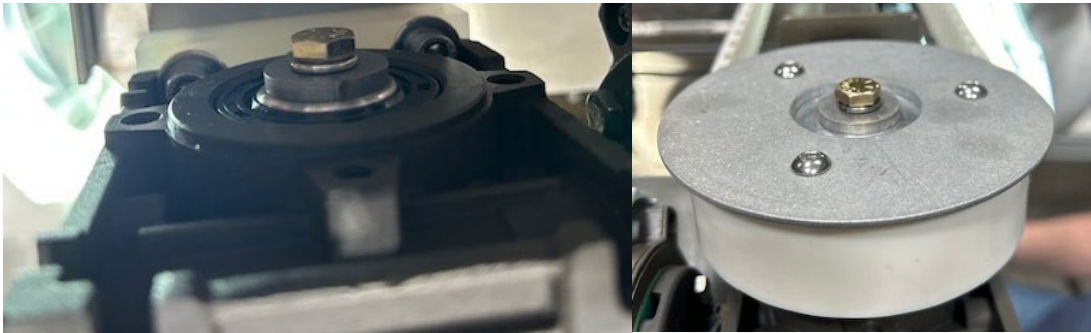
**BEFORE**

1. Remove the old bolt, lock washer, and thick washer from shaft and discard. This reviews the internal threads of the motor shaft.
2. Clean internal threads of motor shaft with brake clean. Wait for it to dry.
